Final Technical Report

Timber High Rise Buildings and Fire Safety

Authors

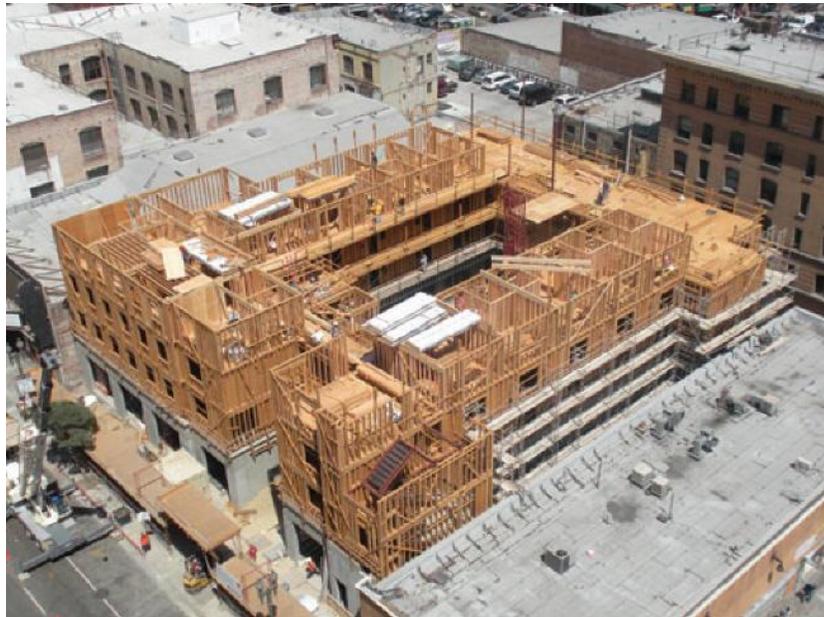
Figure 1. Type V wood frame construction.

Light-frame timber construction is a system of construction using a repetitive combination of closely spaced members that are typically nail-assembled (Figure 1). Members include dimensional lumber, I-joists, trusses, structural composite lumber, and oriented strand board

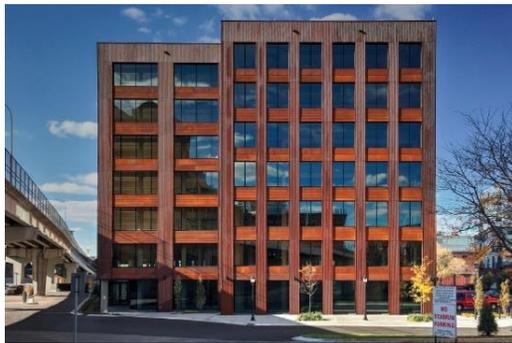
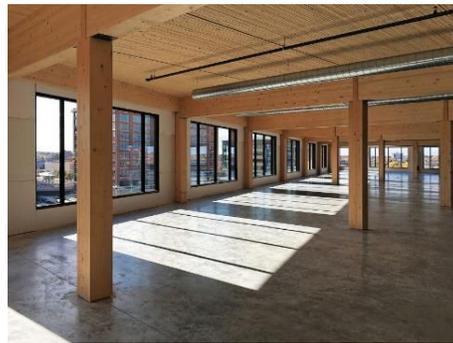
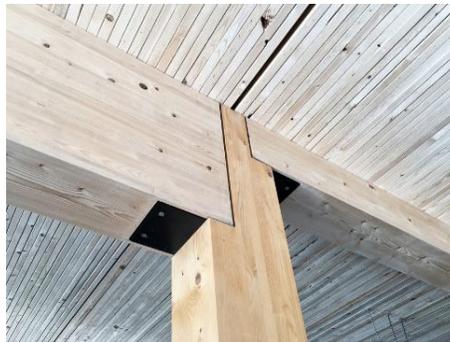
Figure 3. Mass timber Tower in Minneapolis [10]

(a) T3 exterior

(b) T3 interior

(c) T3 structural connection detail

The largest mass timber building in the United States is the T3 building located in Minneapolis (Figure 3) [10]. The building is a seven-story, 220,000-square-foot (20,400 m²) structure. The T3 was constructed of NLT (nail laminated timber) panels combined with a spruce glulam post-and-beam frame, and a concrete topping slab. This building is classified as a “Type IV–Heavy Timber” system by the Minnesota State Building Code. As a sprinklered building, the building is not required to have specific (structural) fire rating. Though its exterior is clad in weathering steel, its interior is simply the timber framework, with the entire timber structure left exposed.

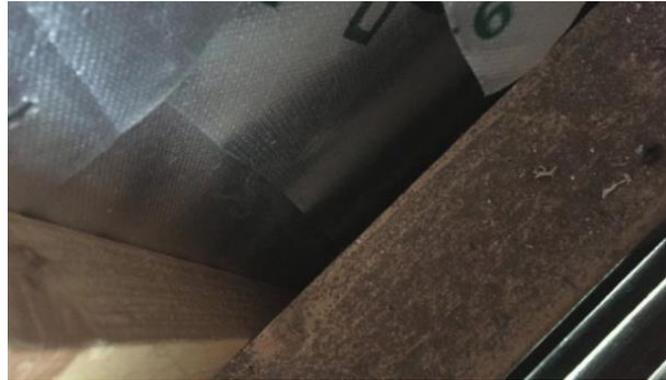
Figure 5. Inspections of properties similar to the one catching fire at Worcester Park showed the presence of large gaps between the fire stopping and the cladding [17].

Following the Worcester Park fire, investigators have looked at similar properties built by the same developer and found flaws in the fire protection measures [17]. Notably, fire surveyors found a

large gap between the fire stopping and the cladding of the other buildings. This could render the fire barrier ineffective, as the gap can act as a chimney for the fire to spread (Figure 5).

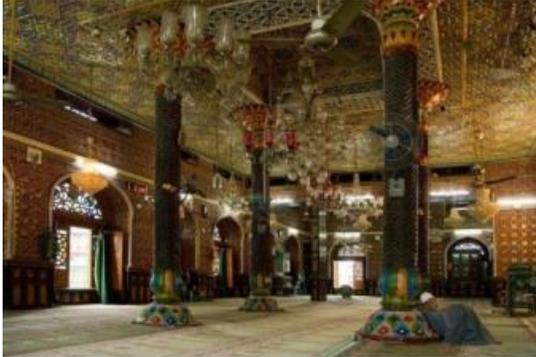
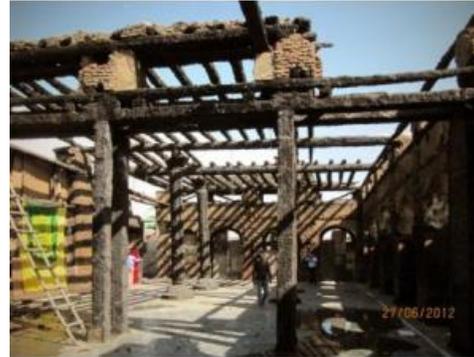
Figure 15. A fire destroyed the Peer Gastgir Sahib Shrine in India, June 25, 2012 [79]

(a) Inside Peer Gastgir Sahib Shrine before the fire

(b) Same view after the fire

When the fire was extinguished, the heavy timber structure of the building was still standing and even found to be of sufficient strength to allow its reuse in a restoration, as shown in Figure 15. The timber members remained sound through the long hot blaze owing to their large size. As the

oversized beams char, the charring progresses slowly and the wood beneath the char layer maintained its integrity, which prevented the total consumption of the timber in the blaze. This fire has led the government to conduct fire auditing of all shrines and upgrading of the fire checking mechanism installed in various Dargahs in India.

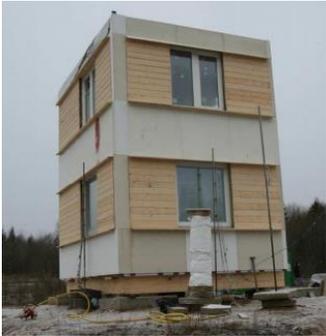
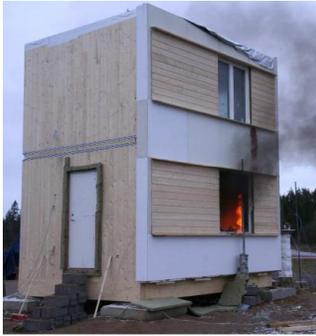
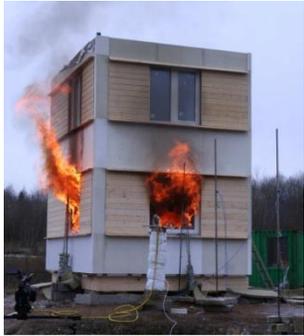
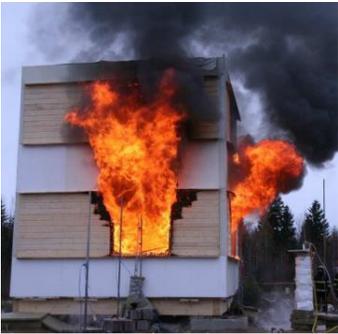
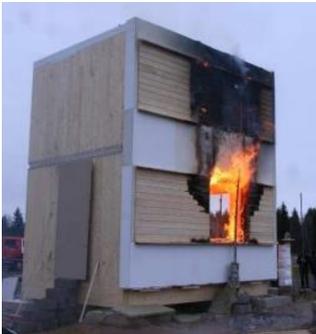
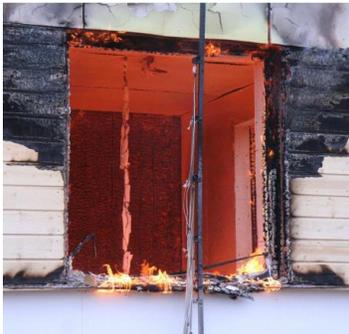
Figure 17. Fire development in the 2017 Karuse test [87].

(a) before the ignition

(b) After breaking the first window, the fire starts to develop

(c) Flames are reaching the facade of the upper floor

(d) Fire has spread to the facades

(e) The flames are subsiding

(f) The CLT is smoldering

Figure 17 shows several stages of the fire test. The fire grew to fully developed and spread to the facade. After consuming the content fuel load, the fire continued through smoldering of the exposed CLT panels. Finally, delamination of CLT appeared and led to a second flashover (Figure 17g), meaning that there was no self-extinction. Hence, the test showed that using interior

exposed wood surface (here, CLT panels) with no active extinguishment system can seriously compromise the fire response of the structure as the structural CLT can fuel the fire and thus prevent its extinction.

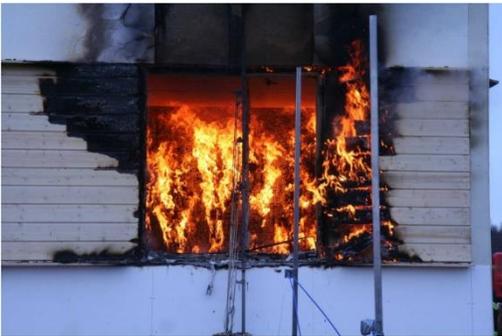
(g) The second layer of CLT is burning

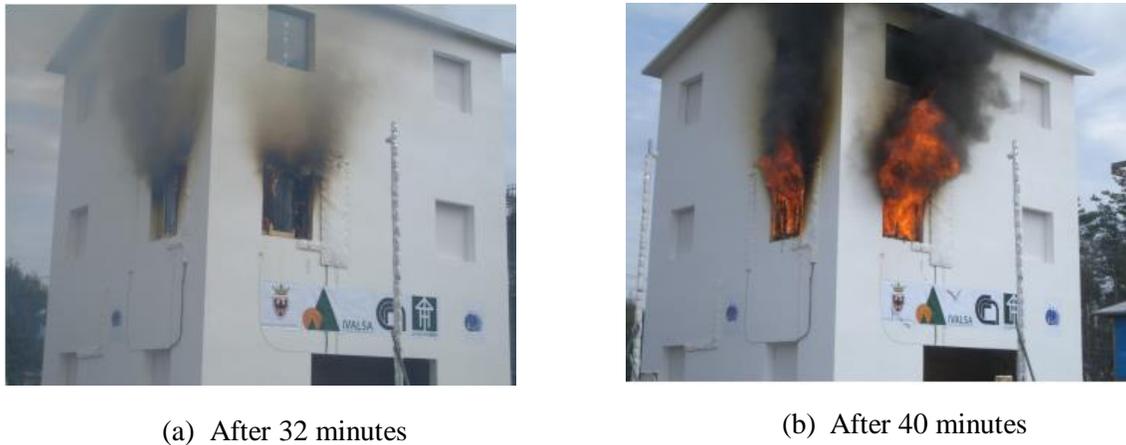
Figure 18. Fire development after fire ignition [88].

A full-scale test on a 3-story building made of CLT panels was performed under natural fire conditions following shaking table tests, as shown Figure 18 [88]. The objective was to check the global performance and identify possible weaknesses of the timber structure. The building had an area of about 7 m x 7 m and a height of about 10 m. The building main structure consisted of 4 outer 85 mm thick CLT timber walls and an inner 85 mm thick CLT wall. The CLT panels were protected by one or two layers of non-combustible gypsum plasterboards. The total fire load density (calculated over the floor area) for the fire room was approximately 790 MJ/m², which includes the contribution from the wood floor. The fire room, with dimensions of 3.34 m x 3.34 m x 2.95 m, was located on the first floor and presented two window openings with dimensions of about 1.0 m by 1.0 m and a door with dimensions of 0.9 m by 2.1 m.

During the test, the fire remained contained in the compartment of origin. No significant elevation in temperature was measured and no smoke was observed in the room above the fire compartment. Hence, the test showed that compartmentation can be achieved for mass timber structures using appropriate protection of the CLT panels (in this case, gypsum plasterboards). Besides limiting the fire spread, protection from gypsum plasterboards also limited the fire damage of the CLT panels.

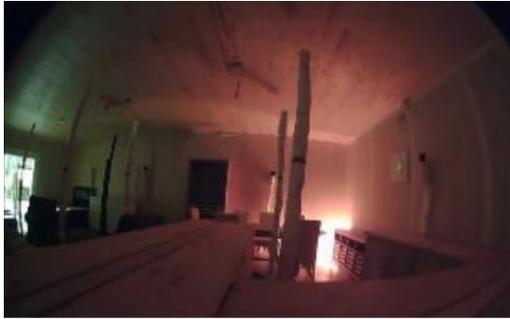
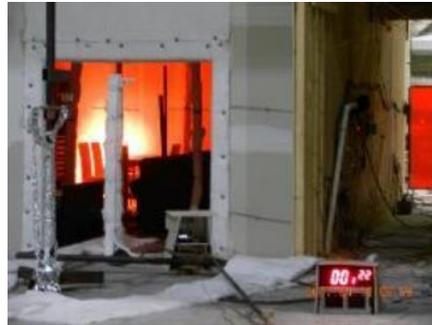
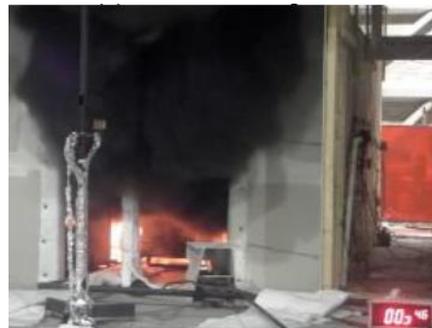
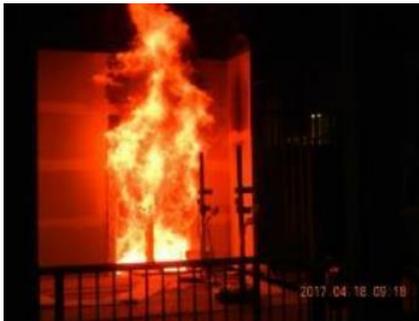
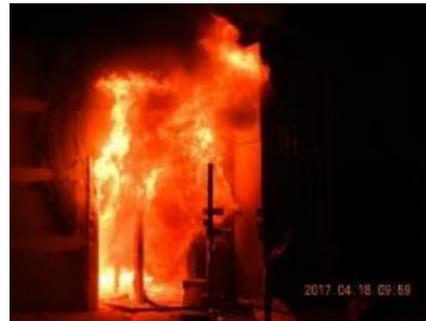
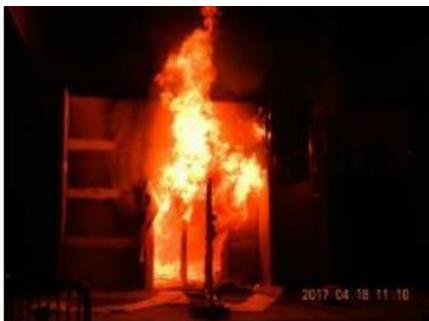
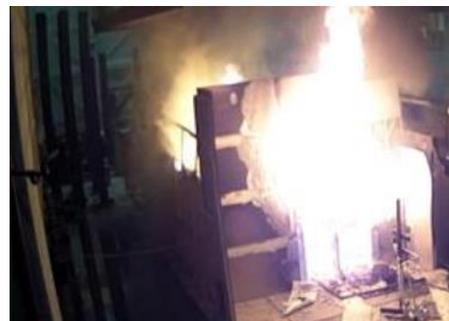
(a) first item ignited in the corner

(b) outside view of ignition

(c) ceiling ignited above the dining area

(d) just before flashover

(e) flashover

(f) at 60 min

(g) at 120 min

(h) at 160 min

Figure 20. Photographs of the CLT compartment during Test 1-6 [90]

The presence of exposed CLT surfaces in four of the tests led to faster flashover by about 3 min to 5 min compared with the two baseline tests with all surfaces protected by gypsum. The peak compartment temperatures were similar in all six tests. However, the heat release rates and heat fluxes to the exterior façade were increased in the tests with exposed CLT compared with the baseline, indicating that the exposed CLT panels increased the fuel load in the test compartments, as shown in Figure 19. Besides, the exposed CLT surface(s) exhibited heat delamination, which led to one or more periods of fire regrowth after decay in three of the tests, and no decay of the fire prior to suppression in the fourth test, as shown in Figures 19 and Figure 20.

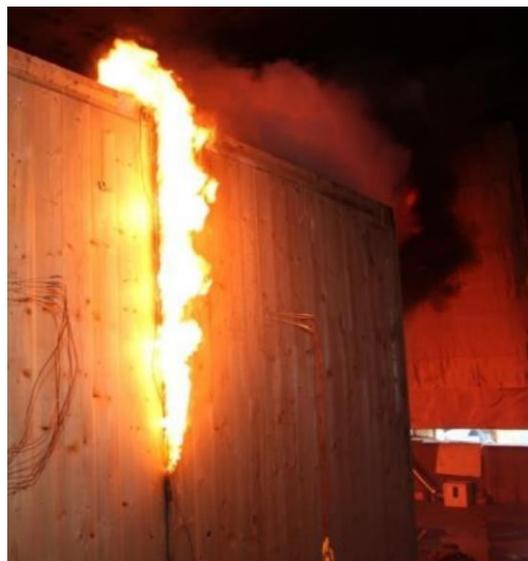
Figure 21. Flaming through a half-lapped joint during the fire test [93]

The heat release rate during the tests with two walls exposed was much greater than the heat release rate of the test with only one wall exposed. The maximum HRR of the test with unprotected walls facing each other was greater than the HRR of the test in which the unprotected walls were adjacent to each other. The charring rate decreased linearly in all three tests as the thickness of the char layer developed. Room temperatures during the early stages of the fire for all three tests were similar as only the room contents were involved in the fire. After flashover, the temperatures in the rooms with multiple unprotected walls decreased at a slower rate than the room with only one unprotected wall. The room in one test had an early integrity failure (CLT panel-to-panel joints through a half-lapped joint, leading to flaming outside of the room, which indicated the importance of using fire-rated caulking to seal CLT panel to panel connection, as shown in Figure 21). The test with one wall exposed did not delaminate and achieved self-extinction. The latter used CLT products from a different manufacturer than the two tests with two walls exposed. In the two tests with two exposed walls, early delamination of CLT plies occurred, leading to a second flashover.

Failure of compartmentation can result from an integrity failure of the structure. For example, reviewed tests have shown fire integrity failure of CLT panels. Section 2.4.3 (Osborne et al., 2012) has shown flame-through of CLT floor assemblies under load, while Section 2.4.2 (Hevia 2014, Figure 21) showed that in one of the tested compartment the room had an early flame-through of the CLT panel-to-panel joints through a half-lapped joint.

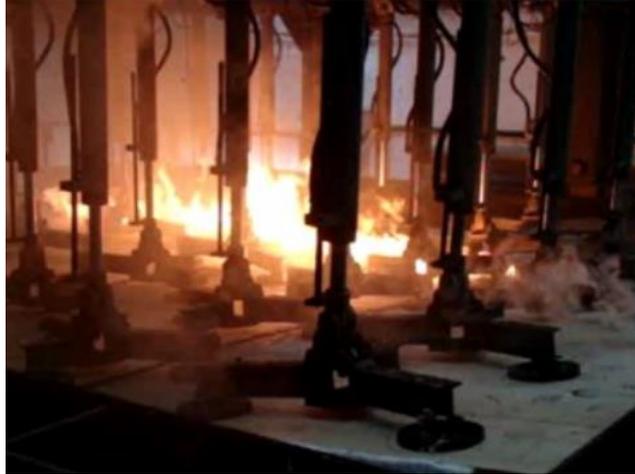
Figure 22. CLT panel-to-panel fire integrity failure (flame-through) [97]

The fire curve is the Standard ULC S101 fire exposure. Each panel measured 763 mm wide. The floor panels were 4786 mm long and the wall panels were 3048 mm long. Each test was on a unique panel with a different number of plies and varying thickness; some of the assemblies were protected using CGC Sheetrock Fire Code Type X gypsum board while others were left unprotected (i.e. directly exposed to fire). The results show that the performance of CLT walls and floors were improved by gypsum board protection; and that the tested charring rate reasonably agrees with the theoretical values calculated according to EC5. The test results have been used to further validate and refine the CLT fire resistance calculation method currently published in the 2011 Edition of the Canadian CLT Handbook. However, the tests also showed that fire integrity is one of the predominant failure modes of CLT floor assemblies under load; flame-through was observed as shown in Figure 22. Such failure mode was not observed in CLT wall assemblies under load. The walls usually exhibit buckling failure due to increased second-order effects (i.e. P- Δ effects) due to charring of the fire-exposed surface.
